According to OSHA, slips, trips, and falls are among the most common causes of workplace injuries. Good housekeeping practices are essential in the workplace and reduce the potential for slip, trip and fall incidents.

Recognize, avoid, and protect workers on all walking/working surfaces by following the tips in this safety topic.

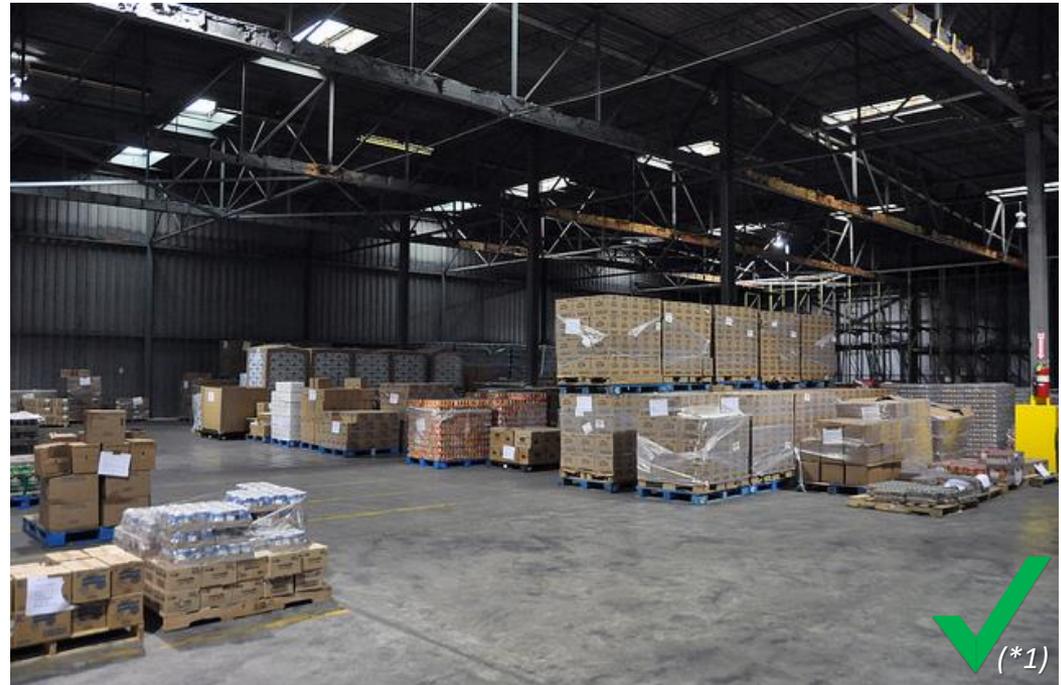
Warehouse with good housekeeping and a designated aisle way.

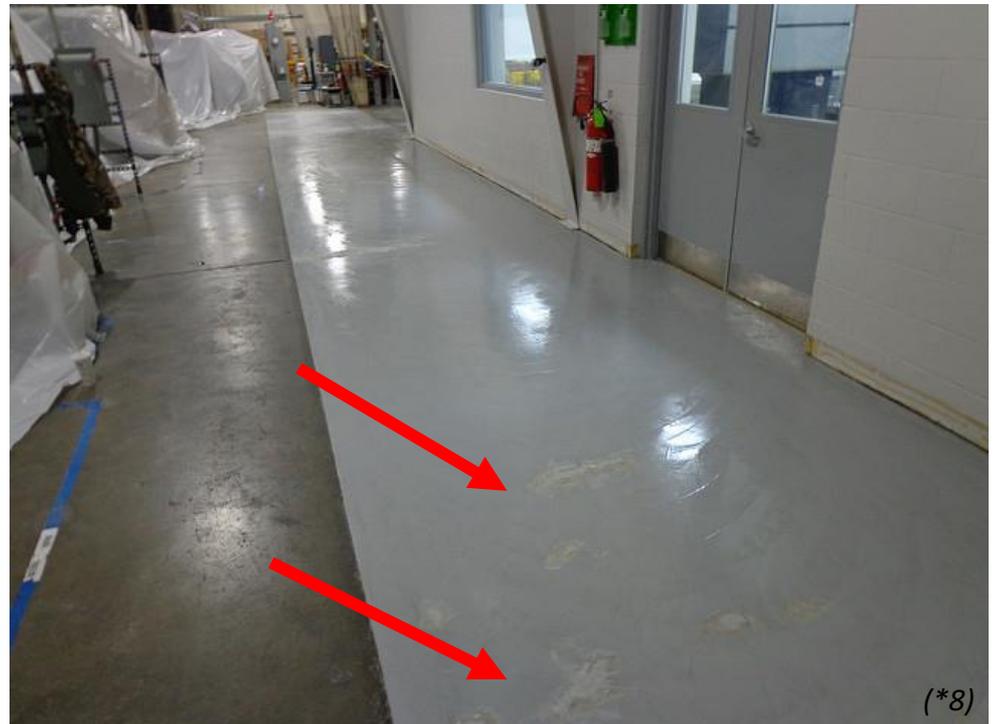
(\*8)

*Concrete walking surface in a facility. Note the irregular areas where the potential for slips or trips are present.*

If repair or maintenance is required to remove the identified slip, trip or fall hazard, and the fix cannot be made immediately, the hazard must be guarded to prevent employees from using the walking-working surface until the hazard is corrected or repaired.

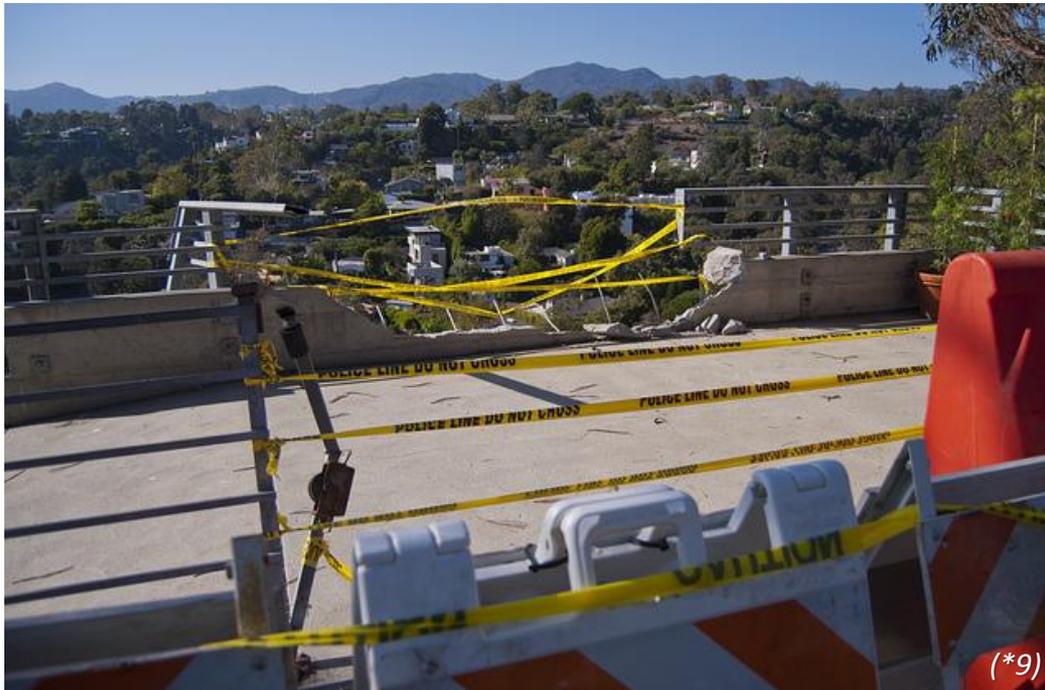
Damaged rooftop guardrail in repair with caution tape used to identify the hazard.

- Short-term hazards due to maintenance, repair or housekeeping should be marked with cautionary floor stands or signs, barricade tape, warning posts and/or chains.

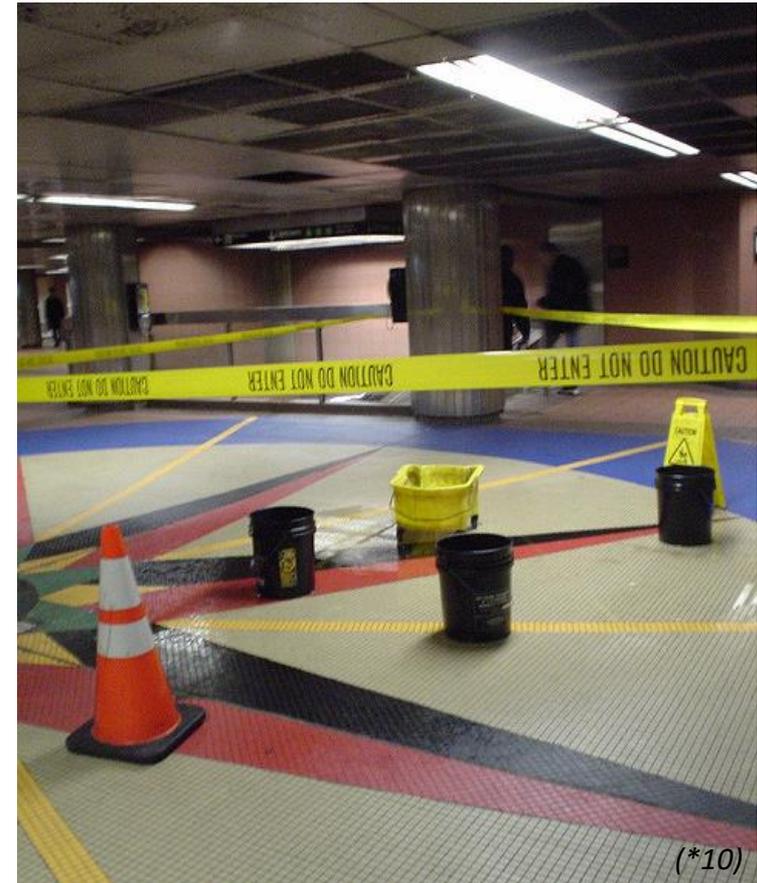
With a leaky roof, slips are a possibility on this floor but the hazard is marked clearly with tape and a caution sign while clean-up is in progress.
